Manhole Inspection Summary

Manhole # S41CC_014MH

Insp Date: **11/10/08 3:10 PM**

Location Address: **rear 902 n central av**

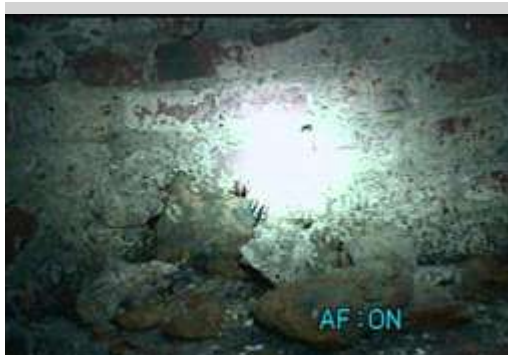
MISC.

bench debris

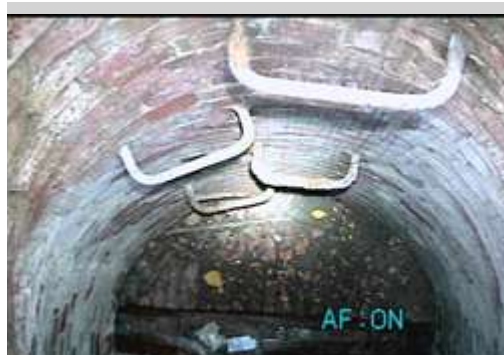
Defect 2

Count: **4** Missing: **0** ☒ **Corroded**

steps corroded

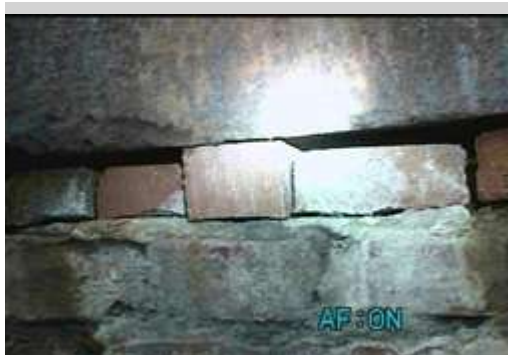
Defect 1

Condition: ☐ Sound ☒ **Cracked** ☐ Root Intrusion ☒ **Loose Brick** ☐ Deteriorated

chimney cracked loose bricks at frame joint

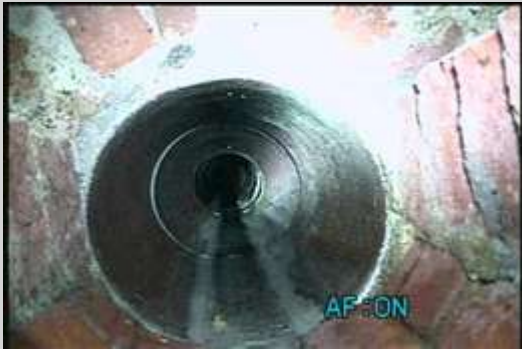
12 O'Clock Outflow

8 in. Circular Gravity Sewer
Pipe Out @ 12 O'Clock

Invert Depth: 8.20 (ft.) Flow Characteristics: **Slow**

Infiltration: **None** Pipe Seal Cond: **Unknown**

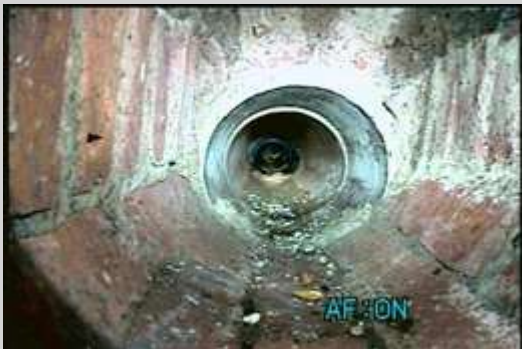
6 O'Clock Inflow

8 in. Circular Gravity Sewer
Pipe In @ 6 O'Clock

Invert Depth: 7.88 (ft.) Flow Characteristics: **None**

Connects To: **Dead End**

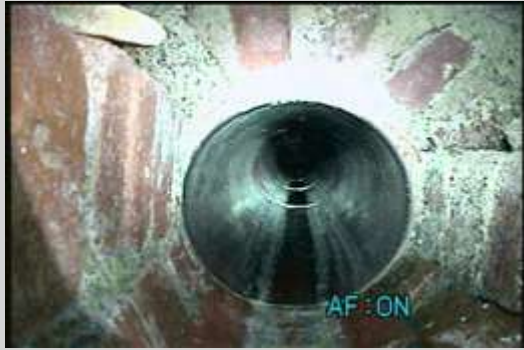
9 O'Clock Inflow

8 in. Circular Gravity Sewer
Pipe In @ 9 O'Clock

Invert Depth: **8.10** (ft.) Flow Characteristics: **Slow**

Infiltration: **None** Pipe Seal Cond: **Unknown**
